Evaluation of the VTA Trial Biodiesel Program

How Do Biodiesel Fuel Blends Affect the Operation and Maintenance of Urban Transit Buses?

VTA Trial Biodiesel Program, October 2008 through February 2015

June 2015

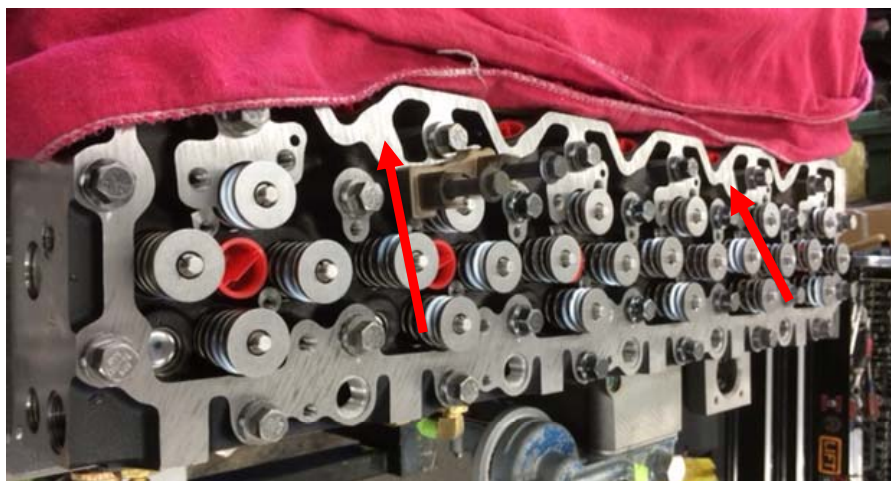
First, the number 2 and number 5 cylinder heads are not cast with the same oiling channels as the 1, 3, 4 and 6 cylinders. The number 2 and number 5 cylinder heads are missing a valley cut which allows oil to flow from the cylinder head down the lifter tubes. This lack of oil flow on these two cylinders can cause cam shaft roller seizures, necessitating entire replacement of the camshaft (and often rebuilding of the entire motor in the process). Figures 7 and 8 detail issues with the cylinder head design.

Figure 7 - cylinder head detail, red arrows point to 2 and 5 cylinder oil channels

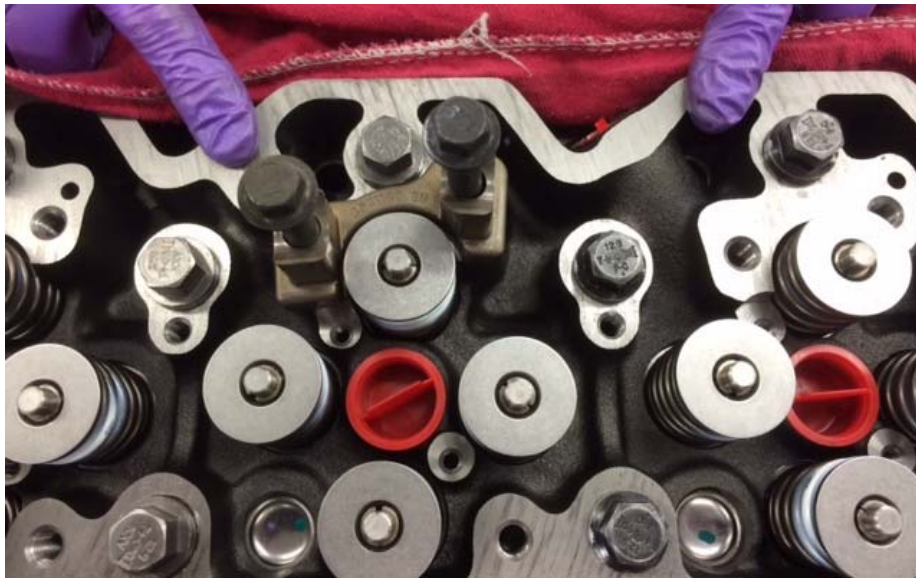
*Figure 8 - close-up showing lack of oil channel on #5 cylinder
Technician's purple-gloved fingers point to oil channel locations. Note the lack of a
oil-channel on the left #5 cylinder. #6 cylinder on right.*

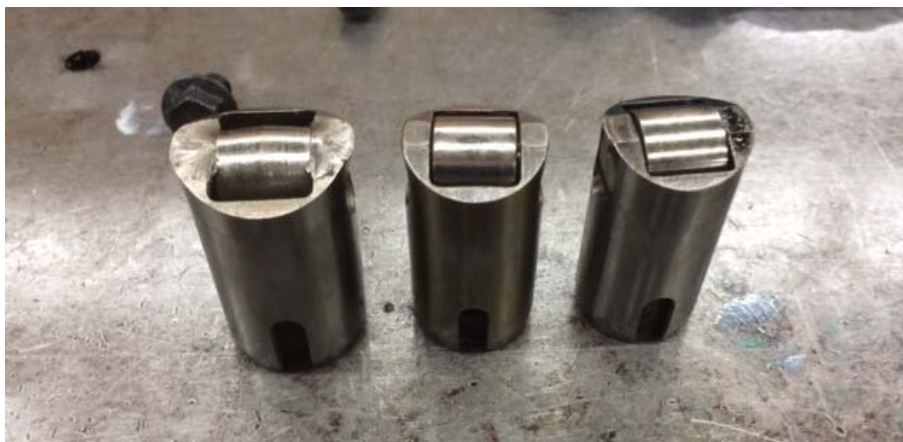
Second, the tappets on the engine initially came in two different sizes; small tappets and large tappets. Oiling issues on the smaller tappets on early engines were mitigated by changing the smaller tappet design to include addition oiling passageways. If an engine block designed for small tappets is rebuilt, the new small-tappet design is exclusively used. If a new engine block is required, it will automatically arrive sized for the large tappets. See Figure 9 for a picture of the two tappet sizes. The rollers on the tappets can seize, as indicated on the large tappet in Figure 9. When this happens, the engine cam and tappets are removed and replaced, unless catastrophic damage was incurred which necessitated an entire engine rebuild.

*Figure 9 - large tappet on left, two small tappets on right
Large tappet roller has seized.*

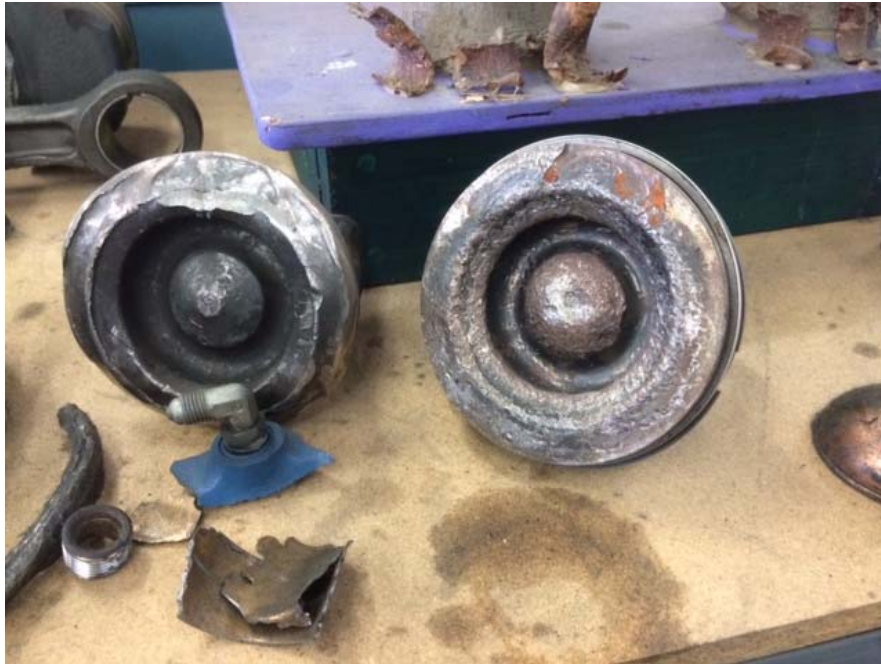
Third, the bushing on the wrist pin at the connecting rod can fail, causing a catastrophic failure of the piston system. When the bushings fail, it is often at high engine speed, which causes significant risk of

serious damage to the engine. In one case, an internal engine failure on a bus travelling on a local highway caused the entire engine compartment to catch on fire. The exact cause of engine failure is not known, but a connecting rod burst through the side of the engine block, causing high temperature oil to spray and immediately ignite on hot engine surfaces. Figure 10 shows damaged pistons due to internal engine failure.

Figure 10 - damaged pistons due to internal engine failure

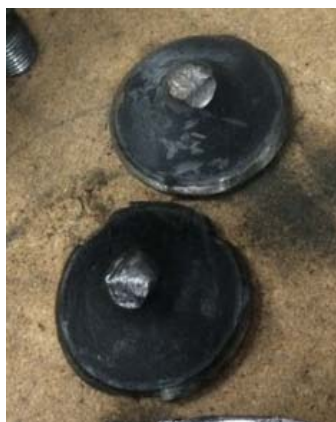
In addition to these common reasons for engine rebuilding, other mechanical factors necessitate engine repair, such as seized main bearings on the crankshaft and dropped valves. If a valve stem breaks, the valve head itself is free to drop into the cylinder, causing piston damage as seen above. See Figure 11 for a picture of valves with broken stems. In addition, main bearing seizure necessitates rebuilding of the entire engine, and is often caused by oiling issues. Figure 12 shows the main bearing on a newly-rebuilt ISL engine.

Figure 11 - broken valves

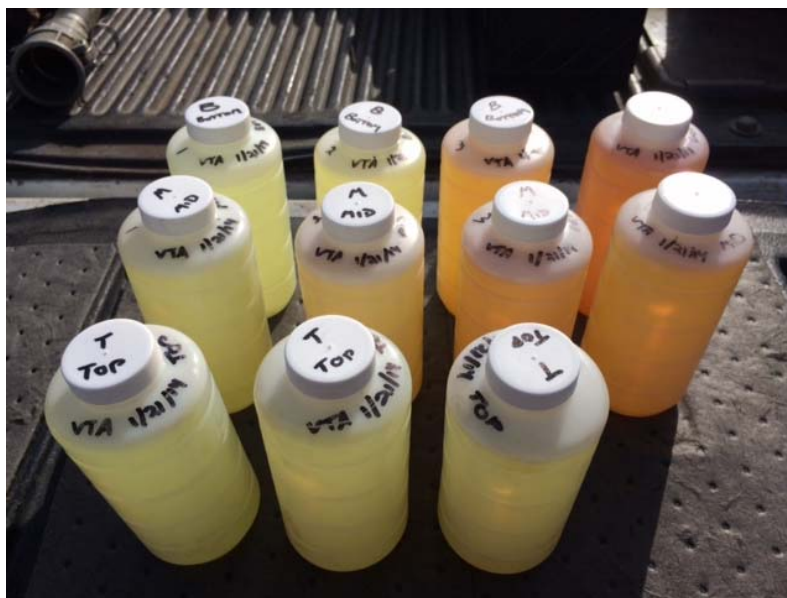
In early January, discussions with SC Fuels led to another round of sampling before corrective action was to take place. SC Fuels wanted to send a set of samples to their own lab and have one of their employees present for the sampling process. 11 samples were pulled in total. The results are shown in the table above, and range from below 1% biodiesel to over 22% biodiesel by concentration.

Figure 13 - January 21, 2014 biodiesel samples from UST

The author of this report was present for the taking of these samples. Of interesting note, when multiple samples were pulled from the same location (i.e. the first, second and third samples consecutively taken from the bottom of the tank), the color of the biodiesel changed, indicating the regional separation of biodiesel was occurring in very small locations in the tank. Figure 13 clearly shows that of the four samples labeled 'mid' (for middle of the tank), separation issues were occurring even at the level where the sample was pulled. Staff confirmed and witnesses at the sampling concurred that the samples were being pulled from the same depth in the tank.

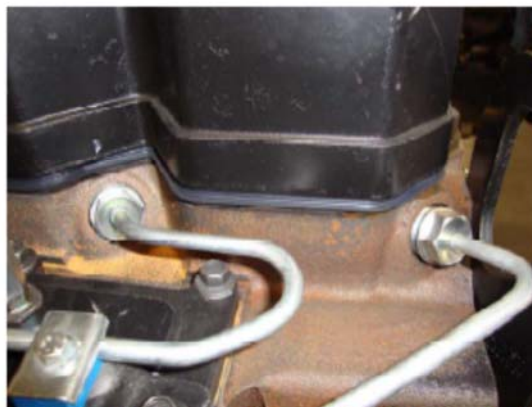
Figure 1 – Fuel line connectors and high pressure fuel lines

1. After all fuel lines and connectors are removed, inspect fuel connector. Look for burrs or deformation around the inlet and outlet sides of the connector, and replace if necessary. Replace the o-ring on the high pressure connector. Carefully push the fuel connector into the cylinder head until it stops against the injector. Be sure to not tear the o-ring as the connector is being installed.
2. Install high pressure fuel lines by first connecting the high pressure line to the cylinder head connectors. Torque to 28 ft-lbs. **DO NOT OVERTORQUE!** See fig. 1.

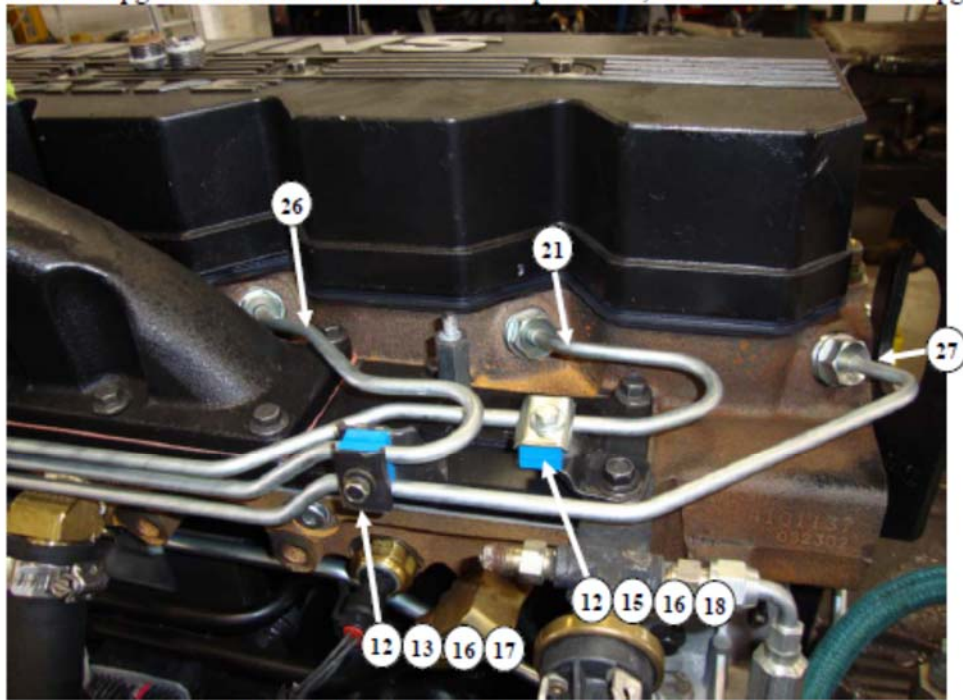
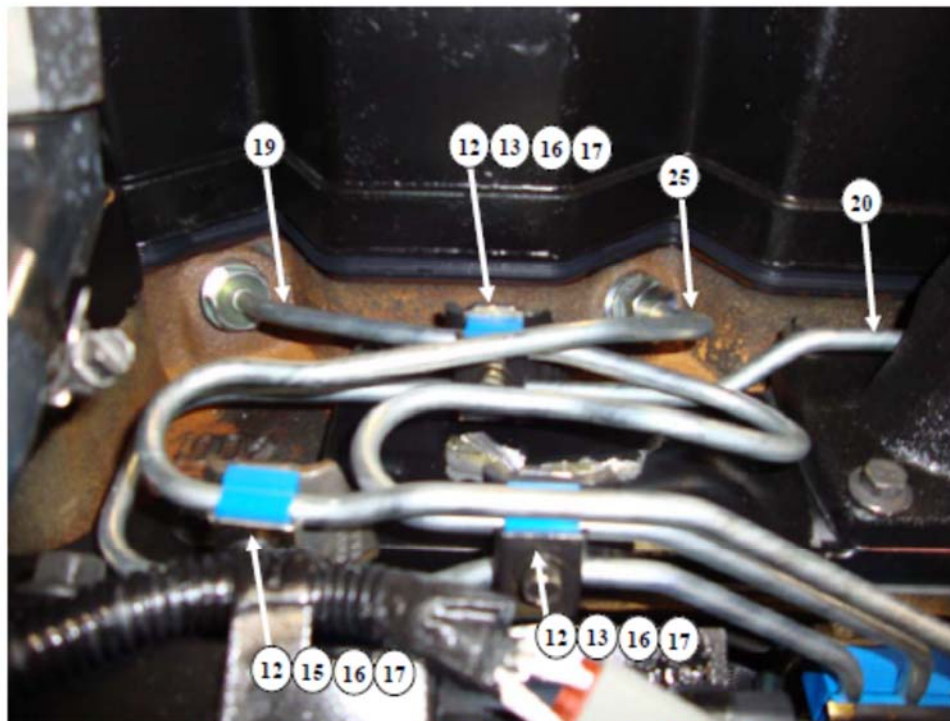
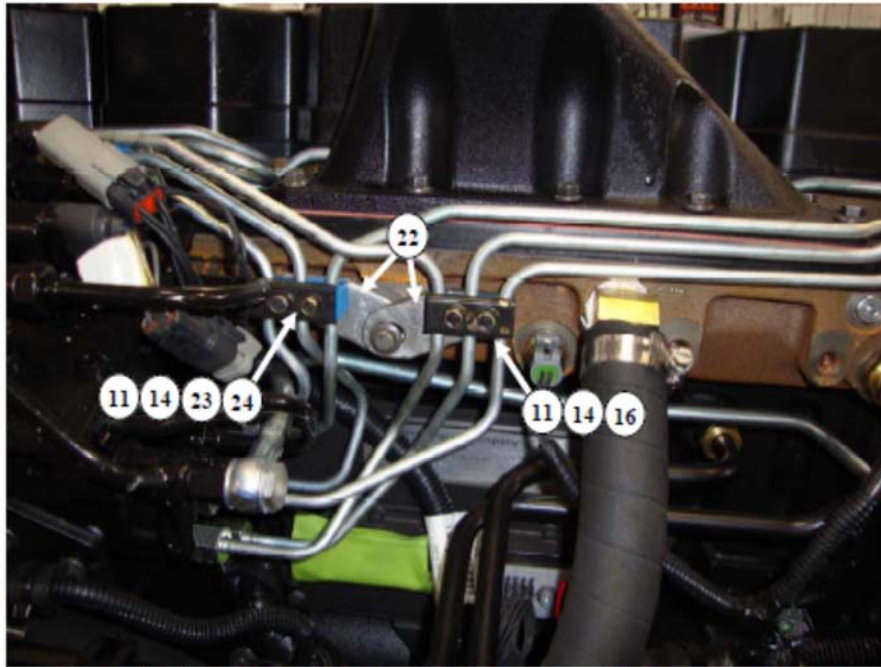
Figure 2 – Isolators and clamps, cylinders 4, 5, and 6

Figure 3 – Isolators and clamps, cylinders 1, 2 and 3

Figure 4 – Isolators and clamps, all high pressure lines near fuel pump

3. Ensure all fuel line clamps, screws, and isolators are in place. See figs. 2-4. For part numbers, see Parts section on pg 4. For information on fastener torque values, see Reference section on pg 4.
