# Mapping of Pavement Conditions Using Smartphone/Tablet LiDAR

## Case Study: Sensor Performance Comparison

Report 24-16

June 2024

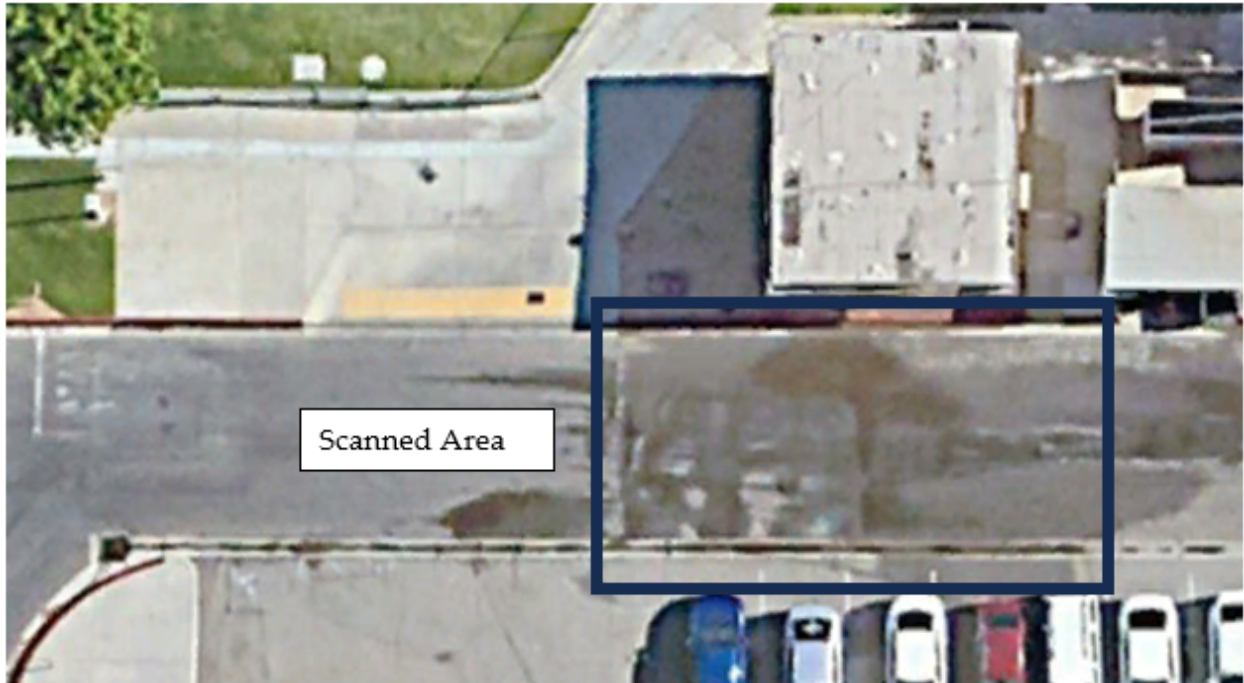
Figure 5. Site #1 on Fresno State Campus

Figures 5, 6, 7, 8, and 9 below display the areas to be scanned and compared. Figure 5 shows an area near the dorms on Fresno State campus, which sees a high volume of vehicle traffic from students. It also receives a high volume of vendors delivering food to the university dining hall.

Figure 5 details the conditions in this area, including cracking in the asphalt, patching pothole areas from construction work, and other miscellaneous defects.

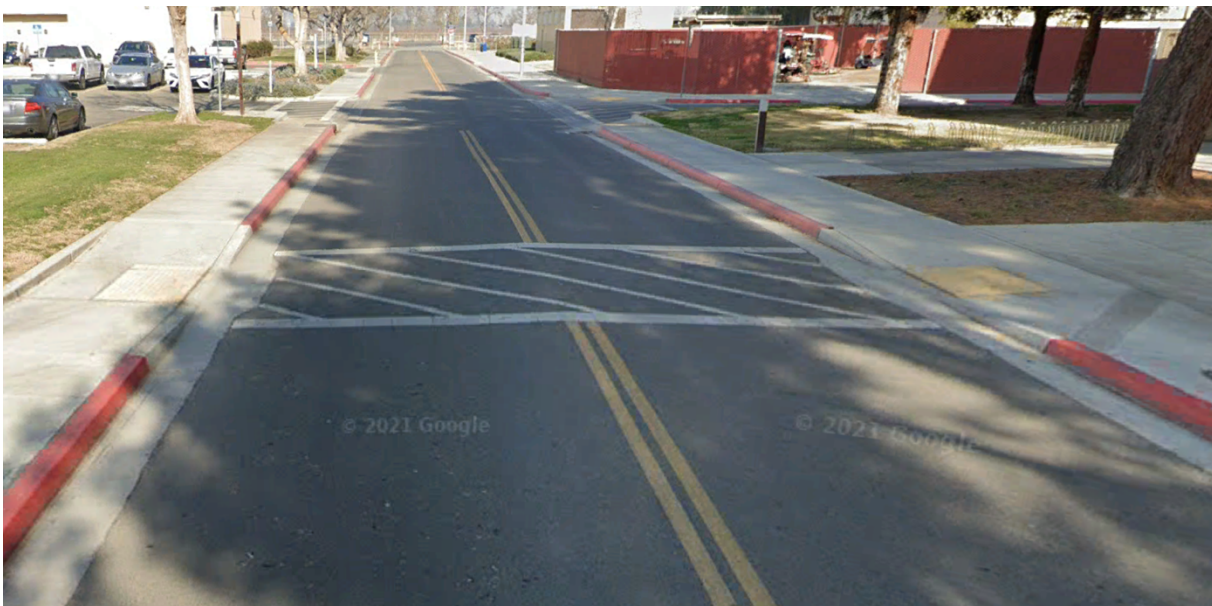
Figure 6. Site #2, on Fresno State Campus, No Known Defects in the Asphalt

Figure 7, site #2, displays a newer road that was recently paved and striped, showing no known defects.

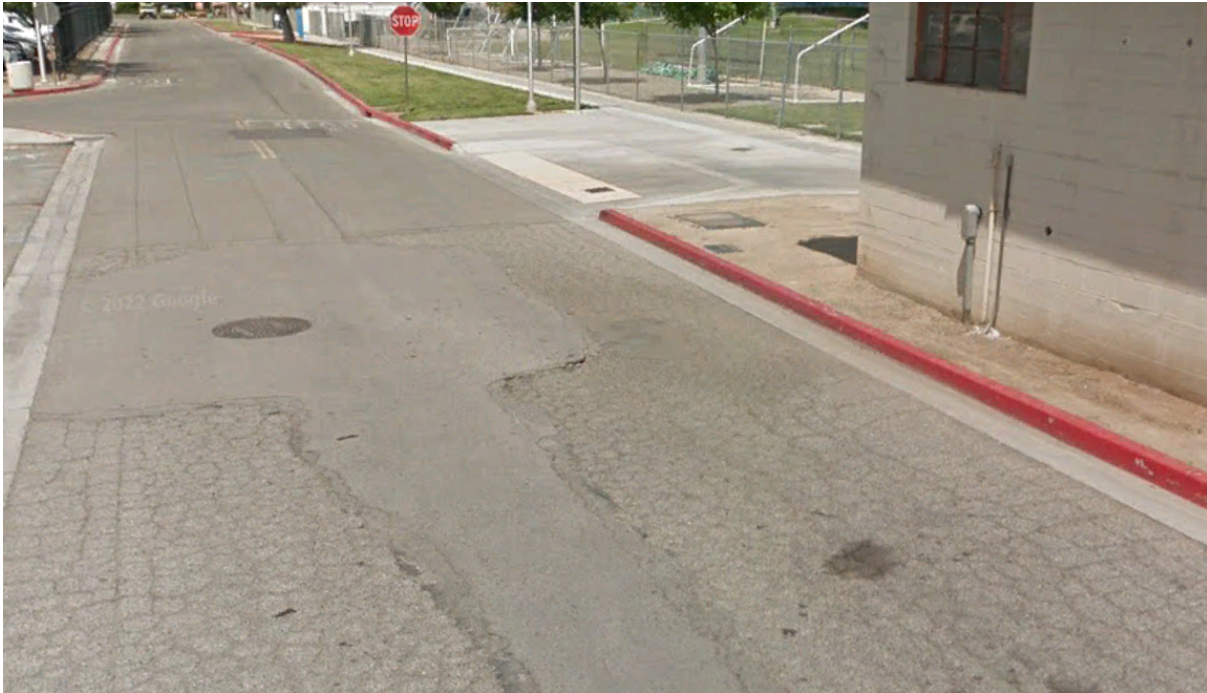
Figure 7. Site #1 on Fresno State Campus, Cracking, Joint Deterioration, Roughness, Surface Defects

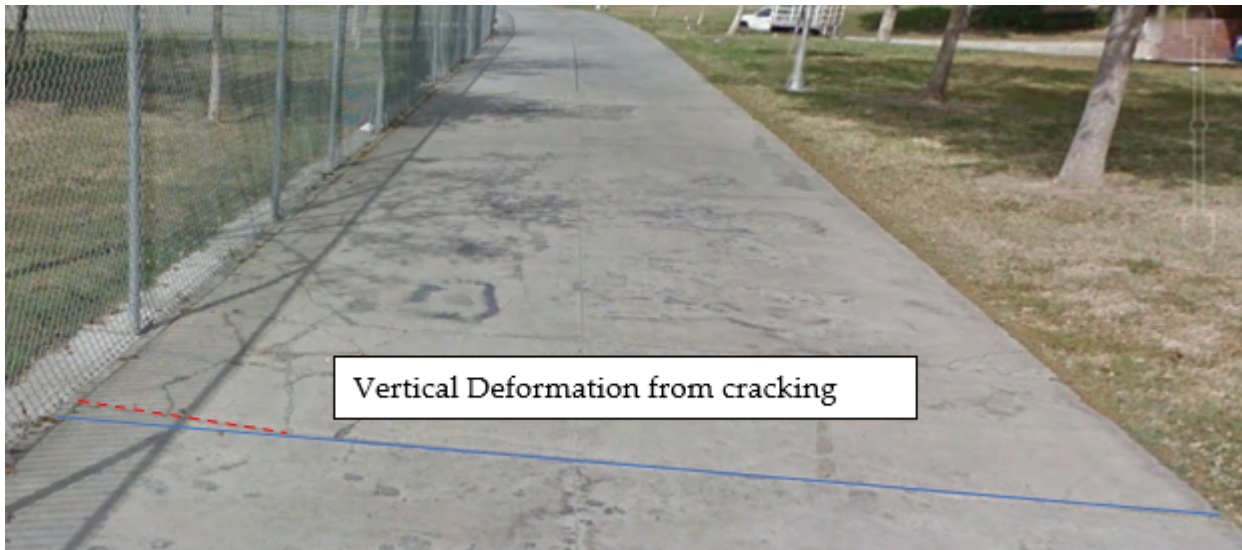
Figure 8. Site #3 Concrete Pavement - Cracking, Joint Deterioration, Roughness, Surface Defects

Figure 8 represents site #3 of a concrete sidewalk used as a common path for students to walk or cycle between buildings on campus.

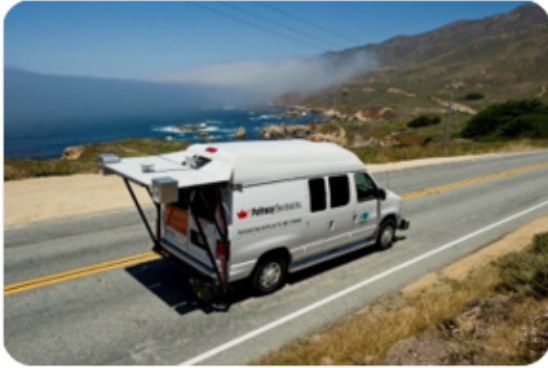
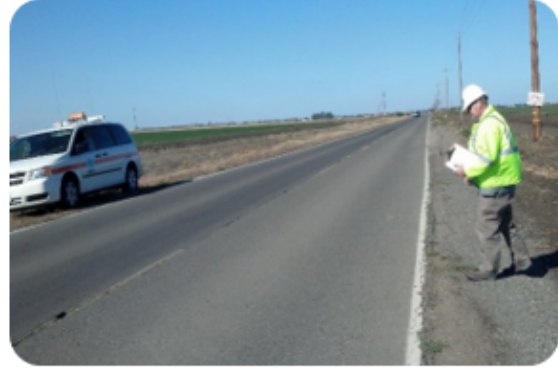
Figure 10. APCS Vehicle on the Road and Manual Pavement Inspection

Traditional inspection is done visually as shown in figure 11 (Caltrans Division of Maintenance Pavement, 2019)(Caltrans Division of Maintenance Pavement, 2019).

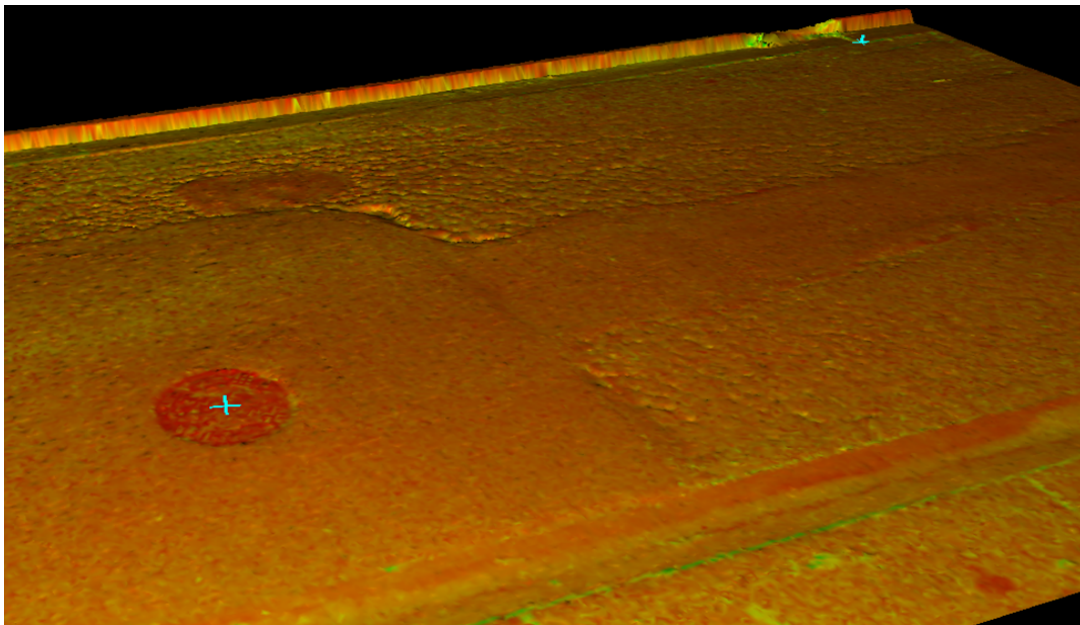
Figure 11. Site #1 Leica P20 Scanner Surface

Site #1 served as the foundation for the level of detail attained using the iPad and iPhone LiDAR sensor. Figure 11 represents Site #1 using the base surface from the Leica P20 Scanner. Several conclusions can be made from this figure. Joint/crack deterioration is visible along the patch lines of the asphalt. Roughness is apparent. Holes in the asphalt are visible and were measured at 3-4 cm in depth. Details of infrastructure are also visible using the Leica P20 scanner. Figure 11 shows details of the manhole and joints in the curb/gutter. The rim of the manhole sits approximately 0.5 cm below the grade of the asphalt.

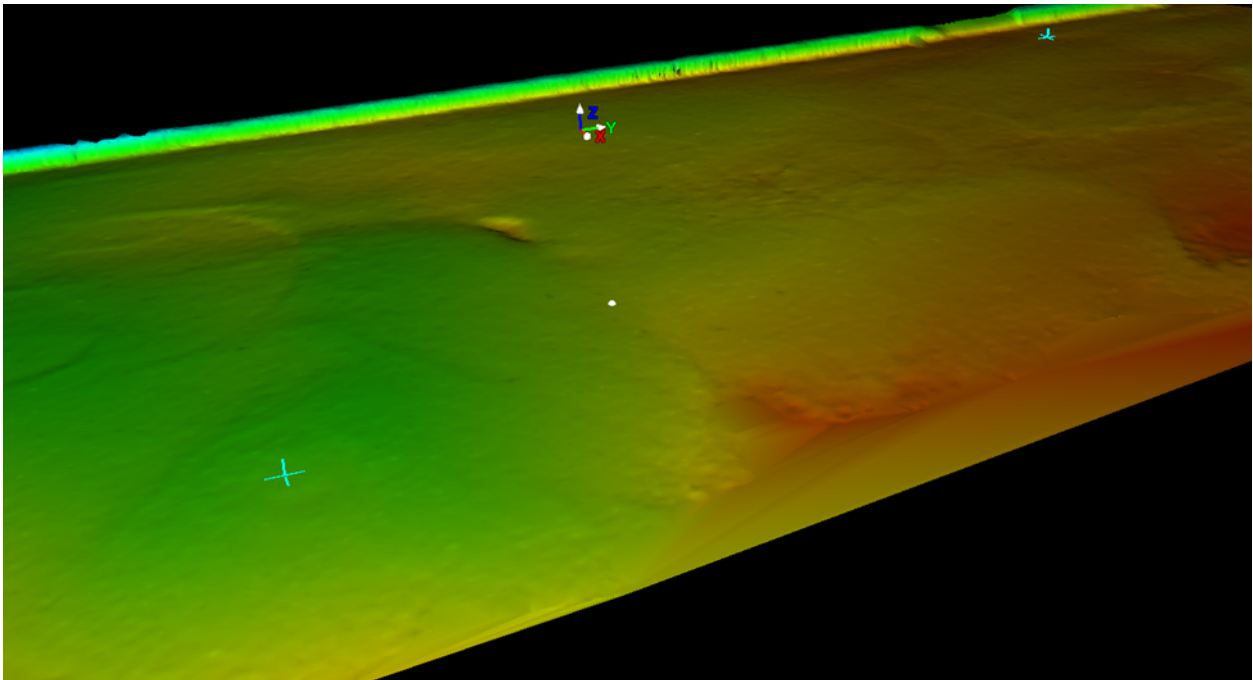
Figure 12. Site #1 iPad LiDAR Sensor

Figure 12 shows the poor results derived from the iPad LiDAR sensor. An inspection with the surface will not bear the same results. The manhole is not visible. Figure 12 shows that the road is smooth. Joints in the curb and gutter are not visible. The iPad sensor did show the hole in the asphalt, but it is nowhere near the level of detail needed to make quantifiable measurements.

The level of detail observed on the iPad Pro-based scans was relatively low across the wide range of scans that we made. During our search through the data, the highest resolution we were able to identify was 1 cm, and we observed nothing in our data that exceeded those results. In general, most of the data we were able to recover only showed details within the range of 2-3 cm at best, and 4-5 cm on average. In both asphalt and broken concrete, only the very worst damage could be seen with the iPad Pro's sensor. Deep, long cracks are often signs of significant damage in road surfaces but are often less than 1-2 cm in width, and thus were barely visible in our collected data. We had the most success picking up surface details like major potholes or areas with wide cracking between older surfaces and newer patches. Details with more points in the z-axis, such as deep potholes and curbs, could be measured with slightly more consistency and accuracy, but details such as cracks and small, shallow potholes that exist on a relatively flat plane were significantly more difficult to measure reliably.

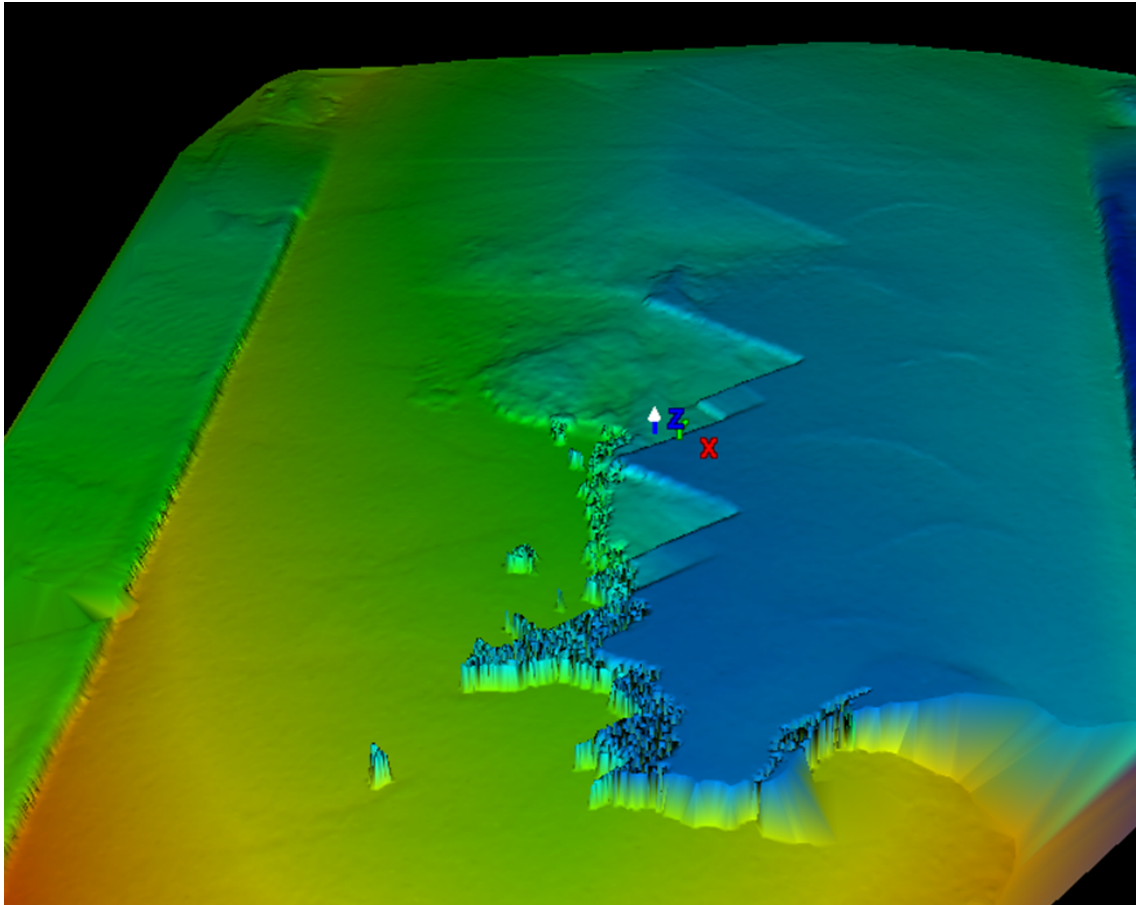
Figure 13. Site #2 New Asphalt

Misclosure on longer scans added a tremendous amount of error to our scans, and the error propagates as distance and subsequent measurements are made. As we lengthened the extent of our scans with the iPad Pro, it was obvious that the errors propagated to the point of creating multiple different layers of surfaces. Figure 13 shows the details of the iPad scan on site #2.

Figure 13 demonstrates the anomalies that resulted from the iPad sensor data. Essentially, three levels of planes are visual. Anomalies in the curb and gutter are present.

A comparison to the Terrestrial scanner was not necessary because the visual inspection does not remotely represent the road.

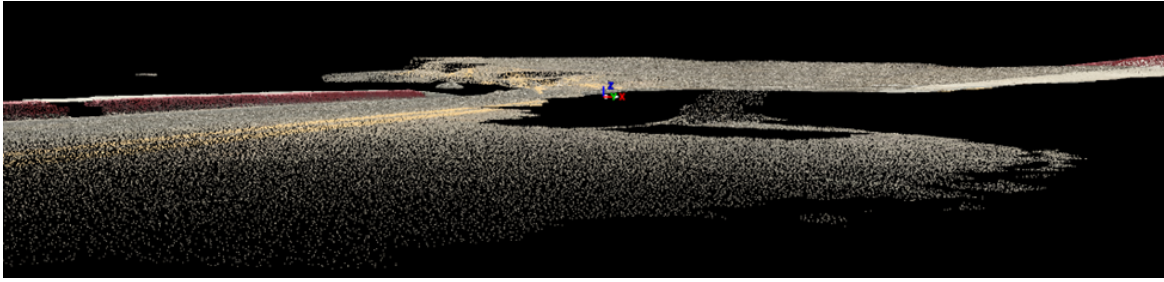
Figure 14. Cross-Section Revealing Vertical Misalignment

On scans that had ends that were not closed, long, linear images generally appeared to maintain a semblance of linearity. However, on scans that closed back on themselves (a traverse of sorts), it was clear that the data contained an unusable amount of misclosure. Many of our longer scans had overlaps that misclosed as much as 10 cm. The app had no recognition of these misclosures/misalignments and would simply take action to mathematically force the misclosed edges to connect. This meant that the surface models it produced were full of large, geometrically shaped edges where none existed on the physical surfaces. As shown in Figure 14, a cross-section of the derived point cloud shows the vertical misalignment on site #2.

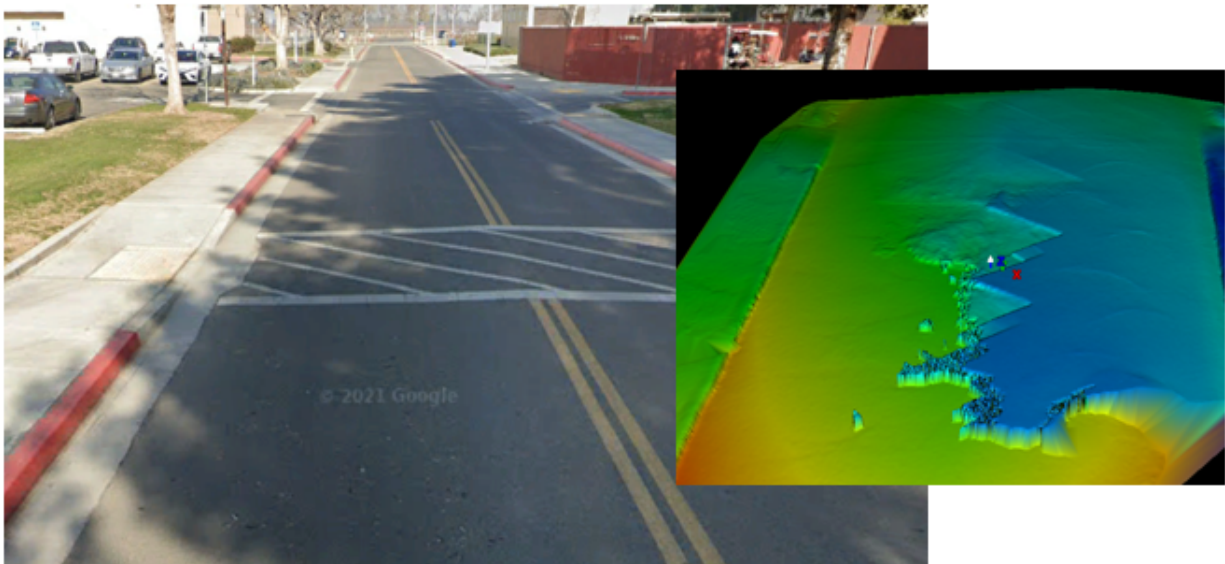
Figure 15. Site #2 Visual Comparison vs LiDAR Comparison

Figure 15 compares the picture alongside the LiDAR sensor data.

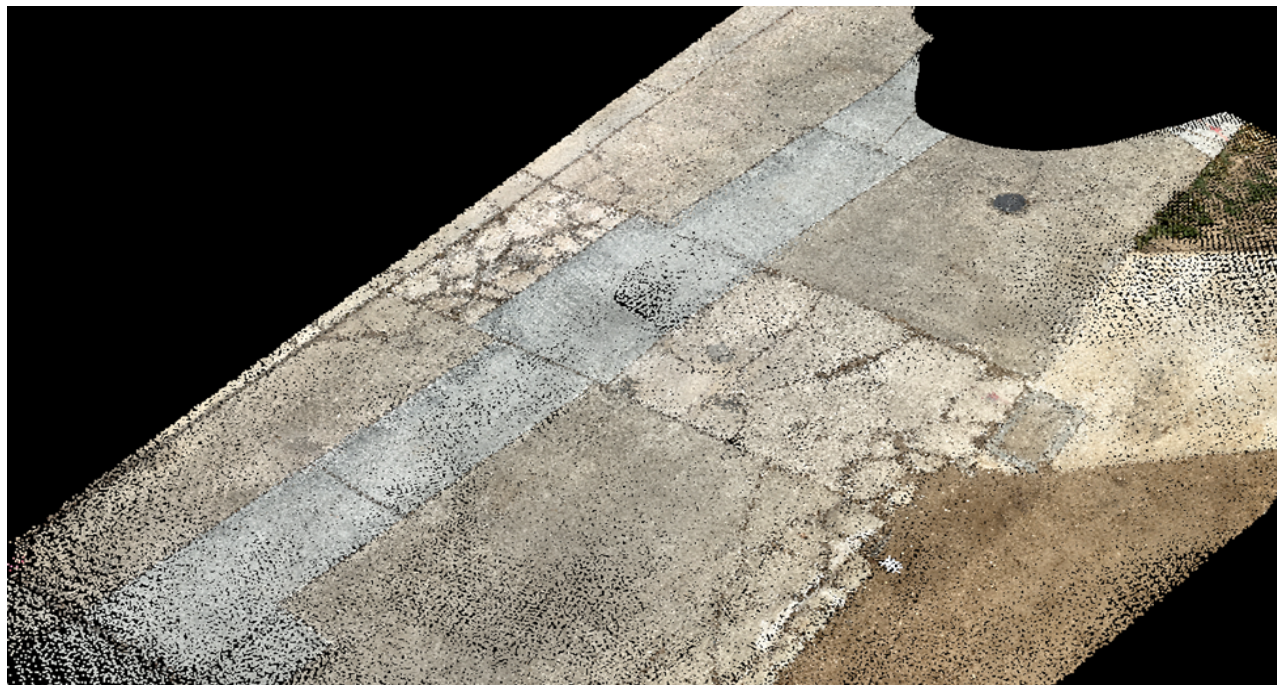
Figure 16. Colorized Point Cloud of Site #3

Site #3 was a concrete surface. As mentioned earlier, it has obvious visual deformation and cracking. The concrete shows evidence of roughness, joint/crack deterioration, surface defects, and grading misalignment (Figure 16).

One slight area of success was using the iPad Pro data in a colorized format. A surface model could not be used to extract valuable data. The resultant surface showed only a smooth finish. No cracking, deformation, or grade changes were present in the derived surface from the iPad data. However, when viewing the points using their true color, contrasting colors would show damage on moderately damaged surfaces. It does create a form of visual inspection, but it is no different from what a digital camera can provide. Cracks in the surface of the concrete were too insignificant

to be visible in the iPad Pro LiDAR data, but light and fine cracking was still invisible in these colorized scans.
