Evaluation of the VTA Trial Biodiesel Program

How Do Biodiesel Fuel Blends Affect the Operation and Maintenance of Urban Transit Buses?

VTA Trial Biodiesel Program, October 2008 through February 2015

June 2015

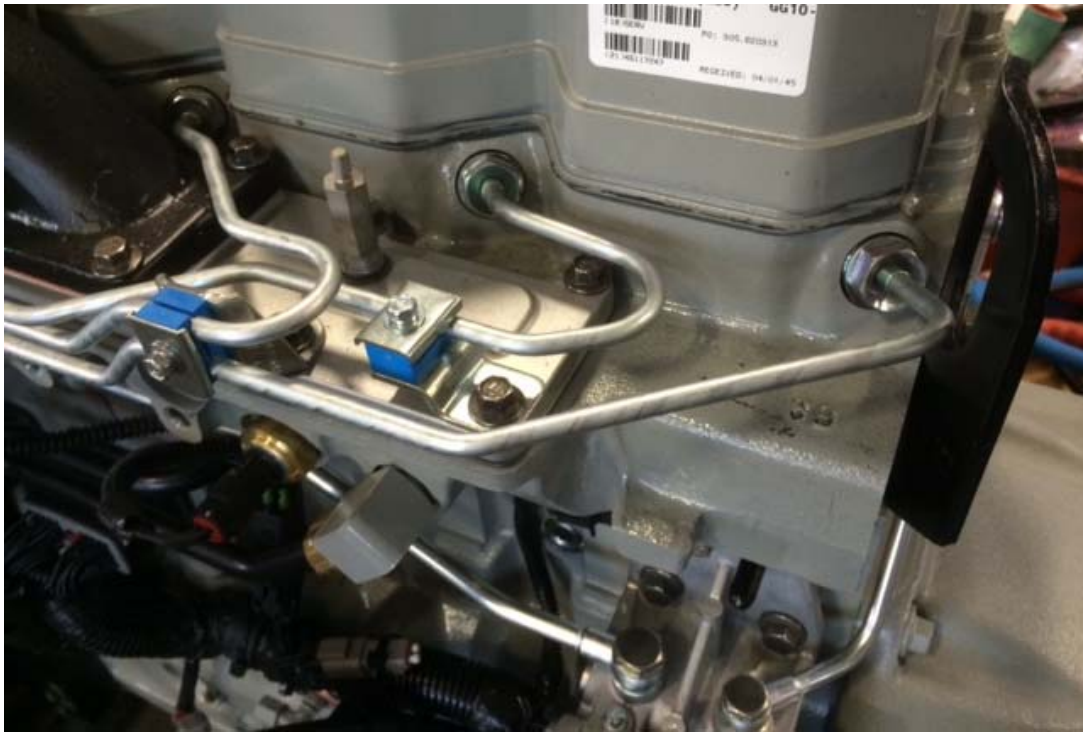
Figure 5 - cylinders 4, 5 and 6 fuel lines

The Cummins ISL uses 6 fuel injectors, each threaded into the cylinder head and sealed with an injector O-ring. The fuel lines themselves are hard stainless lines, pre-bent to shape and connected with fuel line fittings. Due to the length and size of the engine block, fuel lines are held in place with isolator blocks and clamps which keep fuel line vibration to a minimum. Figure 5 shows detail of the injectors, line and isolators.

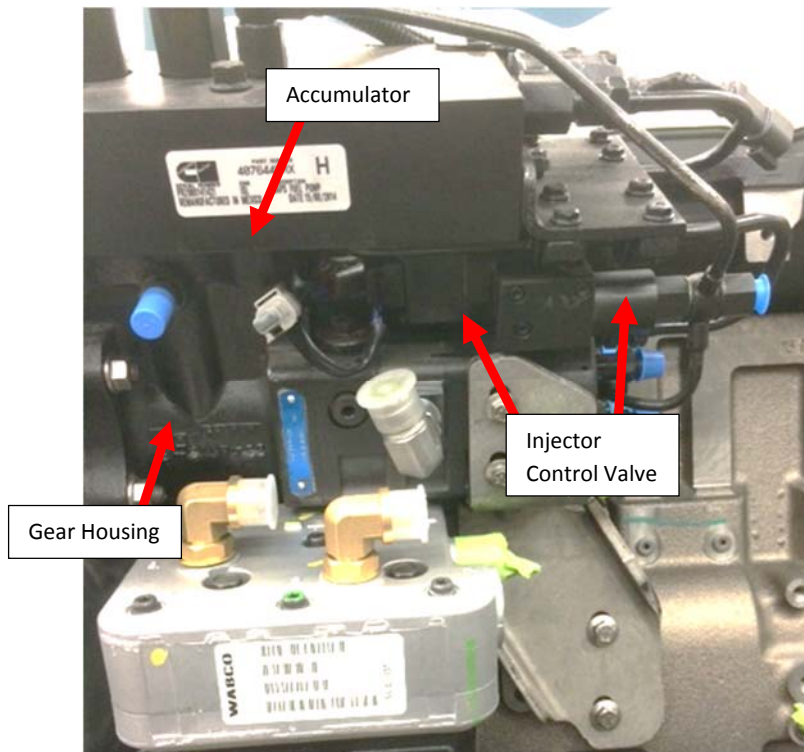
Figure 6 - ICV, accumulator and gear housing detail

The injector control valve (ICV) and fuel distributor take the high pressure fuel from the accumulator and reduce its pressure to 10-14,000 psi (depending on engine operating parameters) and send the fuel to individual injector lines for distribution to the cylinders. Since VTA does not rebuild the fuel pumps and only replaces a few components on the pumps, it's worth noting here that the biodiesel buses used less injector control valves than the standard diesel buses. The biodiesel sub fleet ran 510,000 miles between replacements of the ICV, where the petroleum diesel control group ran 228,000 miles between replacements. When ICV failure is imminent or there are issues with fuel pressure, the engine computer (ECM) can activate a diagnostic trouble code (DTC) which illuminates a check engine light on the dash. Performance issues often accompany ICV failure. Figure 6 shows the location of the ICV on the fuel pump.

Likewise, the accumulator module itself can be replaced independently of the entire fuel pump. The biodiesel buses ran 275,000 miles between accumulator replacements, and the regular diesel buses ran 319,000 miles between accumulator replacements. The accumulator is also shown in Figure 6.

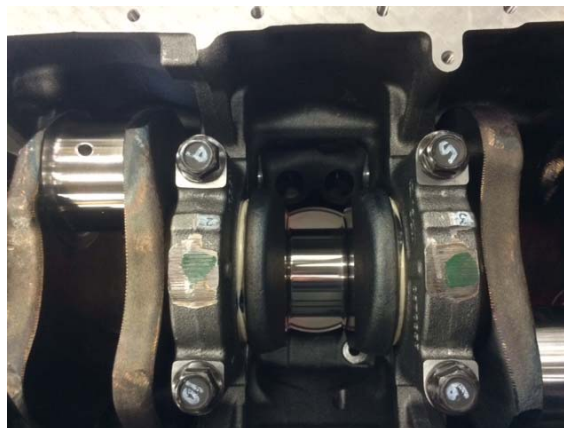
Figure 12 - crankshaft main bearings

In addition to these common reasons for engine rebuilding, other mechanical factors necessitate engine repair, such as seized main bearings on the crankshaft and dropped valves. If a valve stem breaks, the valve head itself is free to drop into the cylinder, causing piston damage as seen above. See Figure 11 for a picture of valves with broken stems. In addition, main bearing seizure necessitates rebuilding of the entire engine, and is often caused by oiling issues. Figure 12 shows the main bearing on a newly-rebuilt ISL engine.
