Manual for Cape Seals

Project 1845C
December 2019

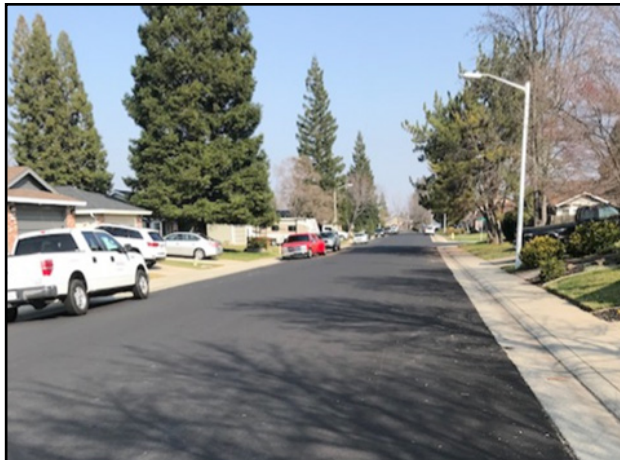
a) What We Want

Figure. Photos of Good and Bad Cape Seal Projects

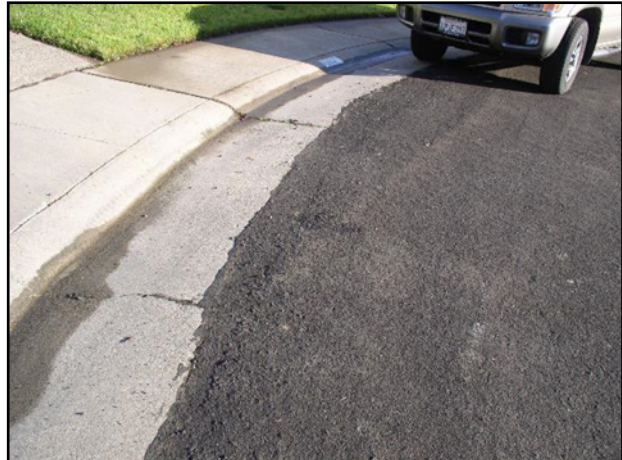
b): What We Don't Want
